## Safety Bulletin

32131A01

### Euro couplings without non-return valve opener

STOCKHOLM April 10, 2012

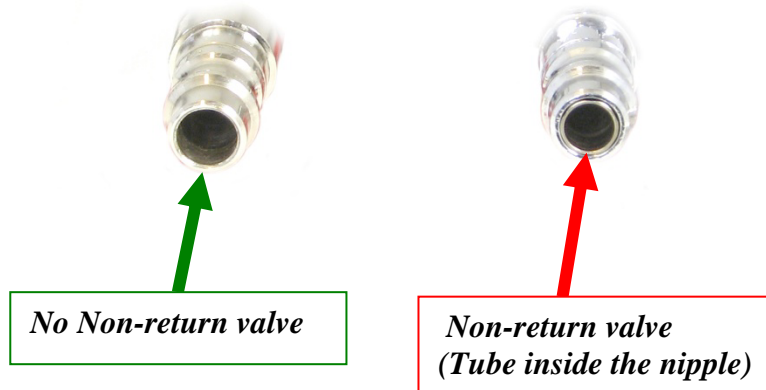
If the SCBA is used in applications where it receives air from another source, it must be checked if the supply hose has a non-return valve or not.

If the male coupling used together with the SCBA is without Non-return valve, no further actions is needed.

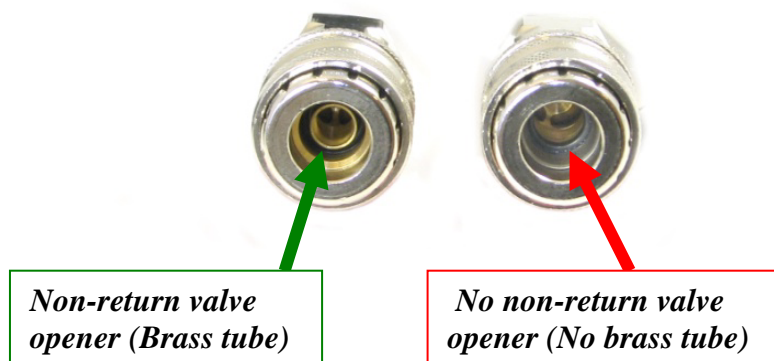
1. Check if there is a Non-return valve opener in the female connection. The non return valve opener is a brass tube located in the female coupling according to picture below. If the female coupling is equipped with the brass tube no further action is needed.

2. If the female coupling is without the brass tube it must be exchanged to the female extra air coupling with item number 95 244-01. Contact your local Interspiro representative for further information.
